ASHI Reporter

Inspection News and Views from
the American Society of Home
Inspectors

Coastal Decks: Red Rust on Decks Is a Safety Warning

FRANK WOESTE, JOSEPH LOFERSKI AND BRUCE BARKER

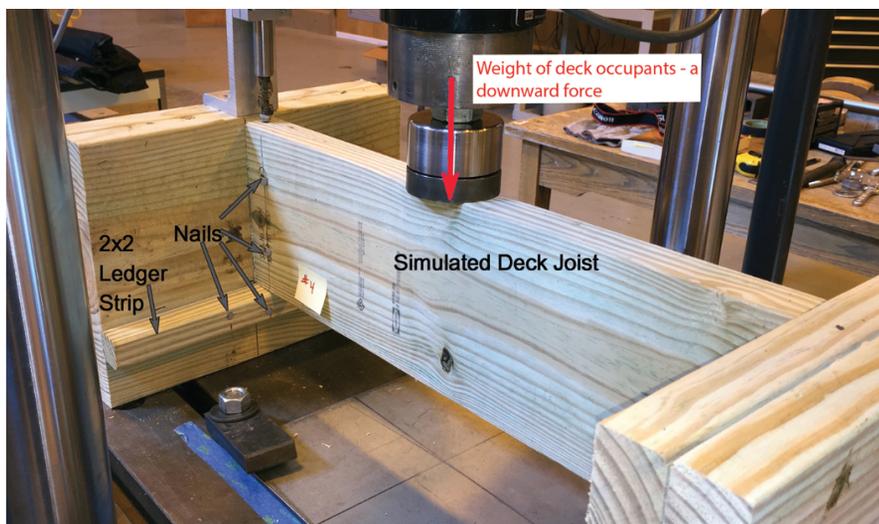
To understand the impact of red rust on deck safety, it may be helpful to review a recent structural load test of a simulated deck floor. In Photo 1, a 2x2 ledger strip is nailed to the lower edge of a simulated support beam. In addition, the deck joist is toe-nailed to the support beam. At the center of the 2x10 floor joist, a vertical load (indicated by the red arrow) is applied to simulate the weight of occupants on an actual deck floor.

Photo 1. Residential decks are designed per code to support 40 pounds per square foot (or one person for every square foot of deck floor area, based on an average weight of 160 pounds).

Referring to Photo 1, the mechanism for this rust and decay begins at the butt joint between the deck floor joist and the deck beam, and between the 2x2 ledger strip and the deck beam. Rain floods these butt joints with corrosive water from above. Rainwater combined with corrosive saltwater cannot dry quickly in these butt joints, creating the ideal conditions for nail corrosion and wood decay. This means that the nail shanks get smaller in diameter from corrosion and the hole in the wood gets larger from decay. This is a bad situation that only gets worse over time and continued exposure. Evidence from coastal deck collapse events validates the mechanism of nail shank corrosion and wood decay described above. Photo 3 shows an example of this corrosion.

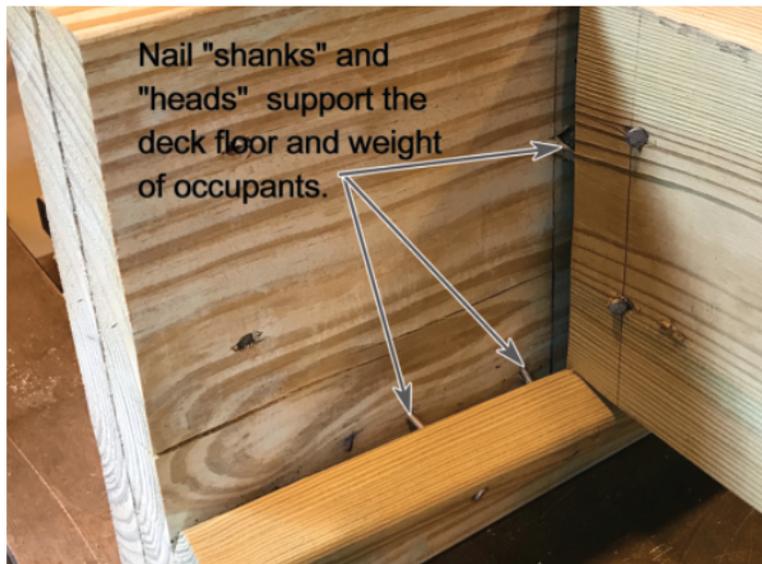
Photo 2 depicts the test specimen after testing, showing the steel nail shanks and nail heads that supported the joists during the application of the simulated occupant load.

Photo 2. A test specimen after the test load was removed. The entire simulated occupant load was supported by the nail shanks and heads. For actual decks with this detail, occupants are supported in the same way.

Thus, it can be concluded that the ability of a deck floor to support occupants is totally dependent on the integrity of the nail shanks (and nail heads) depicted by the arrows. Simply stated, visible red rust and rust stains are a warning that critical structural elements of a deck may be unsafe, and at a great risk of collapse.

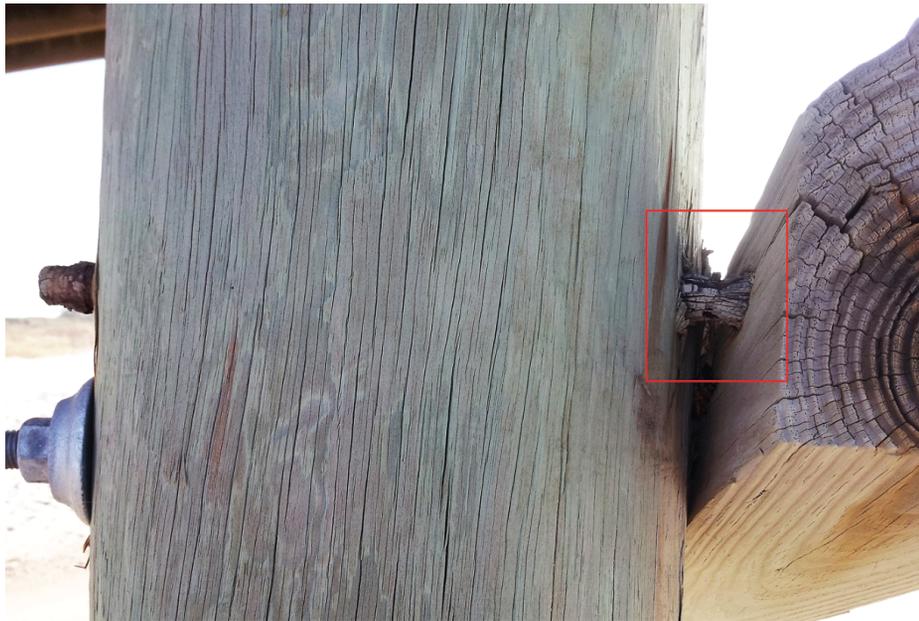
Photo 3. The old bolt is severely corroded and reduced in diameter compared with the newer stainless steel bolt below.

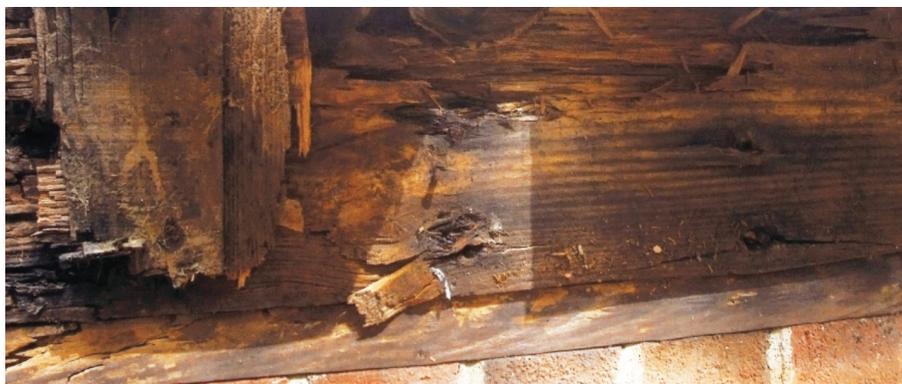
Photo 4. Inadequate flashing contributed to the decay of this band joist where a deck ledger was connected. No quantity of fasteners will secure a deck to this band joist.

Failure of the critical deck-to-house connection often is caused, at least in part, by absent or improperly installed flashing where the deck ledger is attached to the house. Inadequate flashing at this butt joint between the deck ledger and the house creates the same issues as previously described. Corrosive saltwater enters this butt joint, corrodes the fasteners and causes the wood to which the deck ledger is attached to decay. Photo 4 shows an example of a severely decayed band joist resulting from water intrusion.
